# Miller Park Investigation

Milwaukee, Wisconsin

Southeast Wisconsin Professional  
Baseball Park District and The  
Milwaukee Brewers

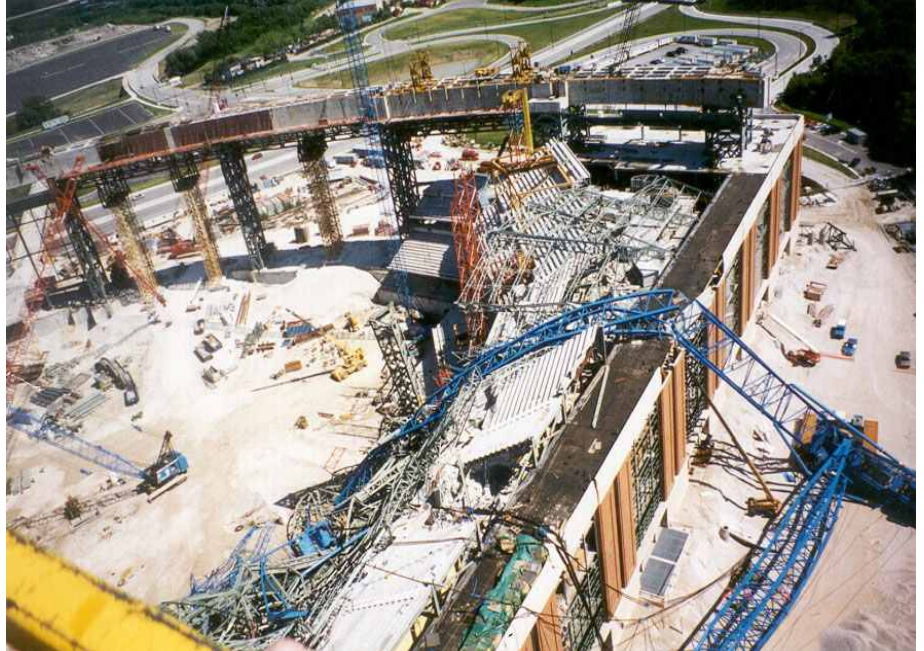
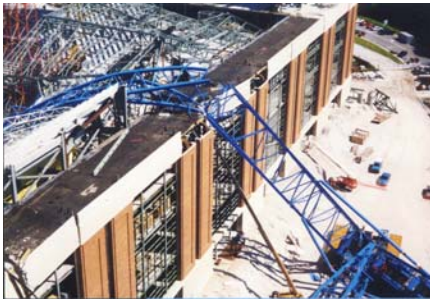
Thornton Tomasetti provided emergency response services and conducted a structural failure investigation and collapse analysis of a 500-foot tall mobile crane that collapsed onto the seating bowl of Miller Park (Milwaukee Brewers' baseball stadium) during its construction. Thornton Tomasetti personnel remained on-site for approximately five months performing stabilization and damage assessment services. In addition, an exhaustive structural investigation was performed including three-dimensional finite element analyses (linear, non-linear, and dynamic).
